## Case Study of JL Apartment

Presented by Lindsey Urschel and Julie Meyers

JL lives in an apartment that is supposed to be equipped for a person with disabilities. Right from the start, upon entering the building, the hall shows signs that the apartment may present many problems for such people. This is a two-bedroom apartment. Some alterations have been made to better service JL

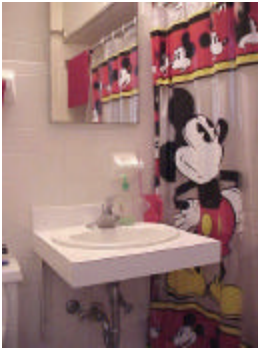
This is a picture of the Sink in JL's bathroom. It is noted that the sink holds enough clearance for her to roll underneath the sink. The problem with this picture is the mirror. The mirror is too tall for her height; it is non functional. This type of error is so frustrating. This apartment housing claims that people with disabilities will have wheelchair access. The simple solution to this problem is to lower the mirror. This adjustment would cost very little, but the mirror should have been installed lower when the apartments were constructed or renovated for accessibility. Also, a longer mirror should be installed, so JL could see her reflection at her height, and so could taller people who may visit or live with her in the future.

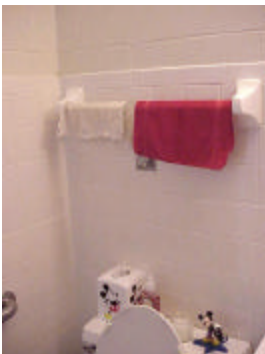
This is a picture of JL's towel rack. The picture already illustrates the problem. The towel rack is too high, and it is in an area that she could not reach. The solution to this problem would be to relocate the towel rack at a lower height on another wall that could easily be accessible for a wheelchair user.

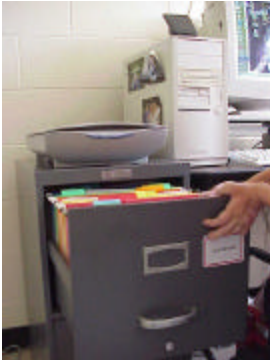
This is a picture of JL using her filing cabinet. The top cabinet is at a good height, but the bottom drawer is useless because she cannot reach that low. This is not part of the built apartment; rather it is a purchased piece of furniture. There may not be a perfect filing cabinet for universal design. However, there could be a file cabinet made specifically for wheel chair users. The bottom drawer could have a high handle that pops up to the higher cabinet's height when pulled.

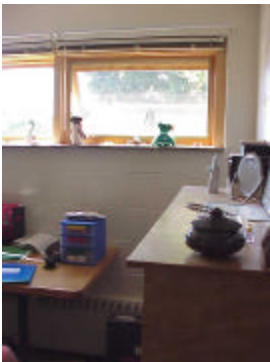
This is a picture of a window in the office area. The window is too high for JL to reach to crank open or to look outside. We also talked about how the deep ledge would obstruct her reach, even if it were a little bit lower. The handle is a lever type that opens and closes the window with rotation. We thought that might be ok for her to use if she could reach it, but she has never had a chance to try. The window needs to be installed at a lower level with perhaps more investigation of the opening mechanism.

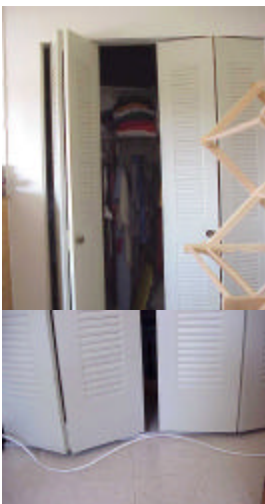
These two pictures illustrate the problems and difficulties of the closet. First of all, the doors are acceptable but not ideal for JL's use. However, the track at the bottom that guides the door stops JL from being able to access the closet. In addition, the shelves are too high to reach, as is the hanging bar. She really has little access to either of her two closets in her apartment. A more ideal design would be pocket doors with handles. A simpler solution would be to place shelving and hanging bars at various levels so that she could reach hanging items and shelved items. The ideal situation would be to install shelving and bars that could move up and down on a rotation. A suggestion might be a dry-cleaner storage mechanism that rotates the clothing and still gets the full height of storage space.

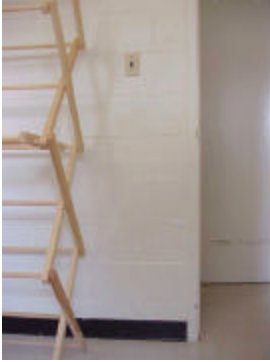
This is a picture of the light switch. It is too high for comfortable reach. JL had some of her switches installed at a lower height. The switches that have been replaced have a connection through a conduit from the original switch to the new switch. A more universal design would be to put the switch at counter height; more groups of people could reach that height. An ideal switch for a better, universal design would be perhaps an invisible laser placed through the lower doorway. When the laser was broken, the lights would come on automatically. This may be tricky, because two lasers would need to be installed for entry and exit with a counting mechanism of the amount of people entered and exiting.

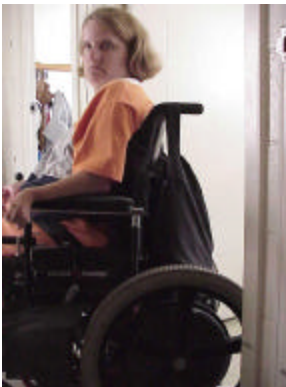
These two pictures show the lack of total organization of this apartment. This shows a small hallway. This small hallway accesses all entries to the bathroom and bedrooms. The door that shows JL is an illustration of the angle she must make to return to her living room, but her chair always hits the side. Even if the doors were equipped with proper handles, she could not turn around in this hallway to shut the door. The bathroom door does not shut when she enters the bathroom with an attendant. Her chair is usually occupying the door area. There is poor space planning and general lack of space. A better plan would be perhaps a more open space plan. No hallways would be required, and all the doorways could be accessible from the larger kitchen/dining room area. This can be tastefully done, and would probably create more space in the apartment with the elimination of the hallway.
