The Bronnenberg House and 2005 Archaeological Investigations at Mounds State Park, Madison County, Indiana

Reports of Investigation 68

January 2006

Archaeological Resources Management Service
Ball State University
Muncie, IN 47306

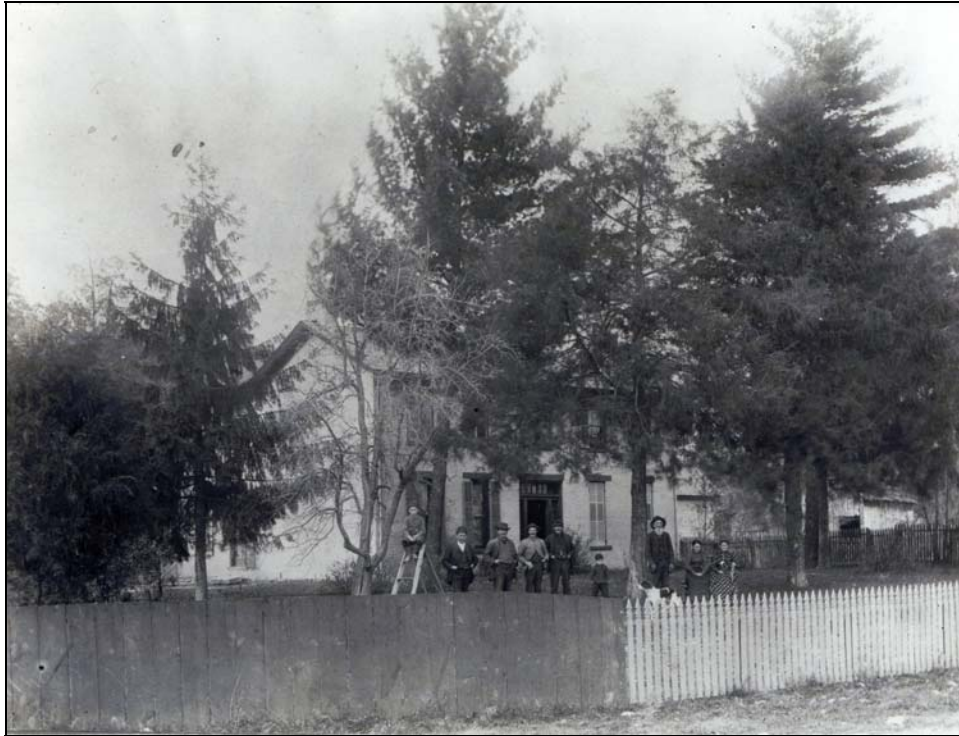
Figure 7. A circa 1890 photograph of the Bronneberg house.

According to census records, Frederick III was renting the property (1900 and 1910 Census). Frederick Jr. died in 1901 and the property was divided between his heirs. When the estate was settled, some of the property was sold to Union Traction Company (Swearingen 2002). Ransom and Frederick are credited with the addition of the second story on the back of the house. The date of the addition is unknown. A circa 1890 photograph shows the second story had been added, but the southern porch had not

(Figure7). A circa 1930 photograph does show the formal southern porch (Figure 8). Changes in family occupation of the house or possible extra revenue generated from the circa 1897 lease or circa 1901 sale of some the property to the Union Traction Company, are possible time periods for the renovations.

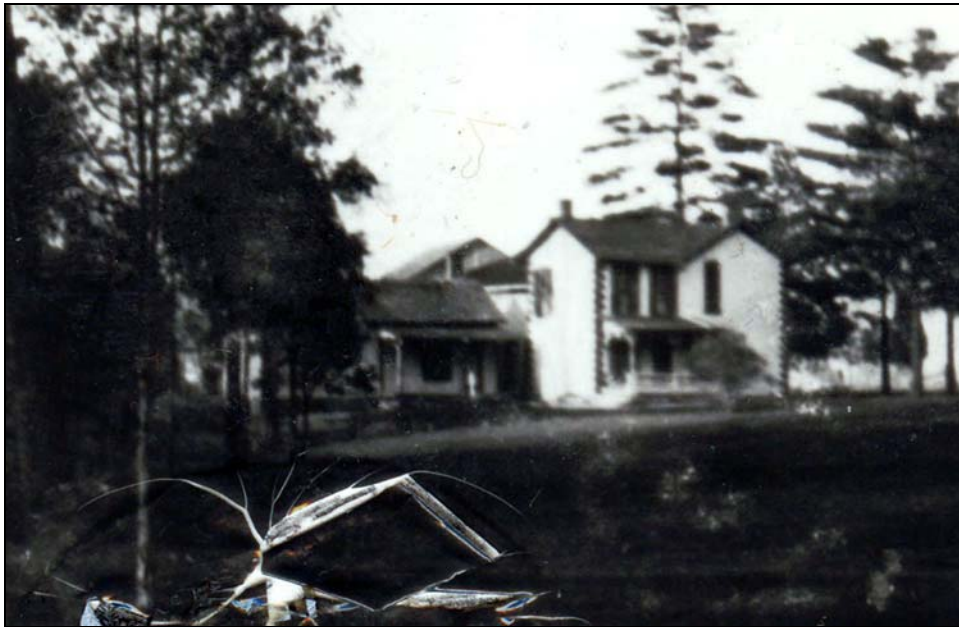
Figure 8. A circa 1930 photograph of the Bronnenberg house.

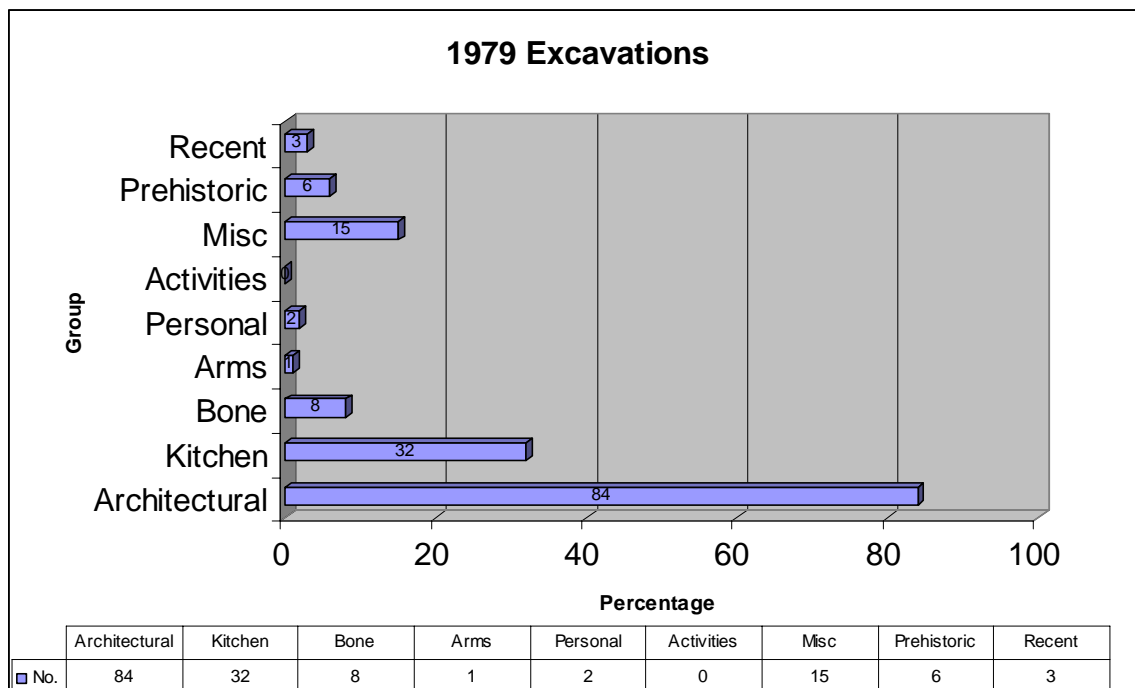
Figure 13. Artifact categories recovered in 1979.

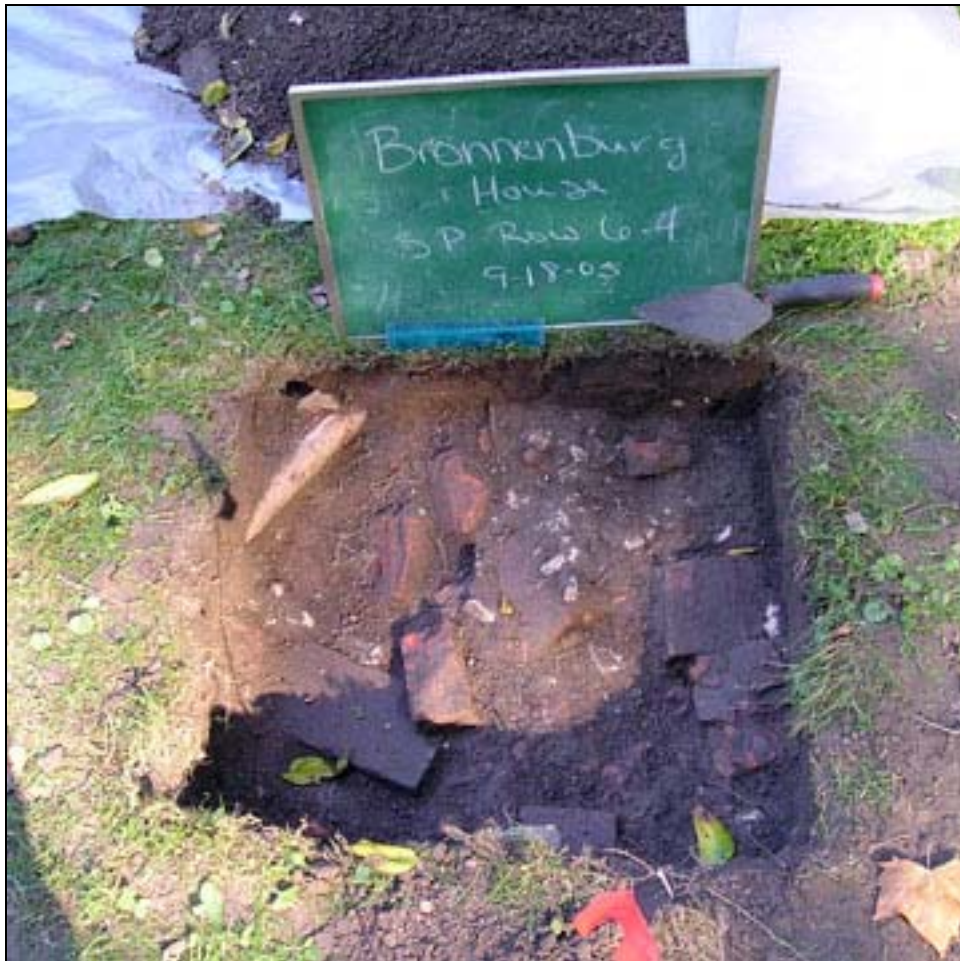
Figure 15. Photo of the brick and mortar fill in the back yard.

From the shovel tests excavated in the back yard and the two western-most shovel tests (#12 and 13) in line 5, a layer of fill was recorded instead of a natural A-horizon at the top of the shovel tests. The fill zone was between 11 and 30 cm bgs. The soil from this zone was similar to the A-horizon found in the side yard, but it contained large quantities of brick and mortar fragments (Figure 15). Shovel test # 6-6 contained a large amount of gravel rather than brick. Shovel test # 8-2 hit a concrete slab at 31 cm bgs. Most of the shovel tests were not excavated below this fill layer.

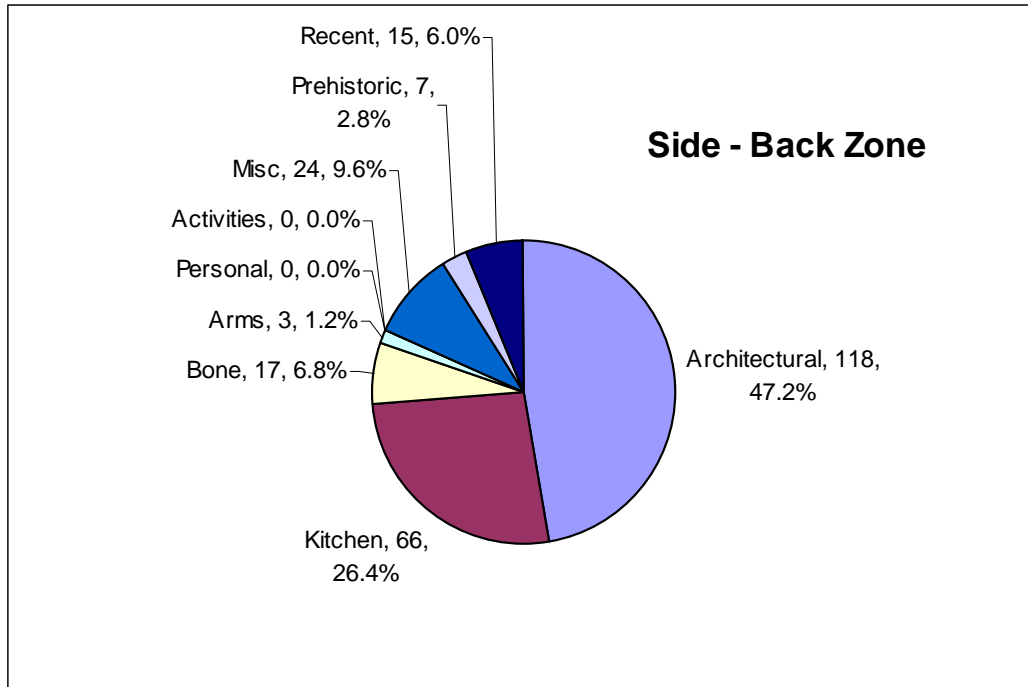
Figure 20. Artifact categories recovered from the back of the side yard.

The largest quantity of kitchen material was also from the back of the side yard. In relation to other artifact groups from the back of the side yard, kitchen materials represent over 25% of the artifacts recovered from this area (Figure 20). Potentially related to the kitchen group, the highest quantity of bone was also found at the back of the side yard (Figure 19).

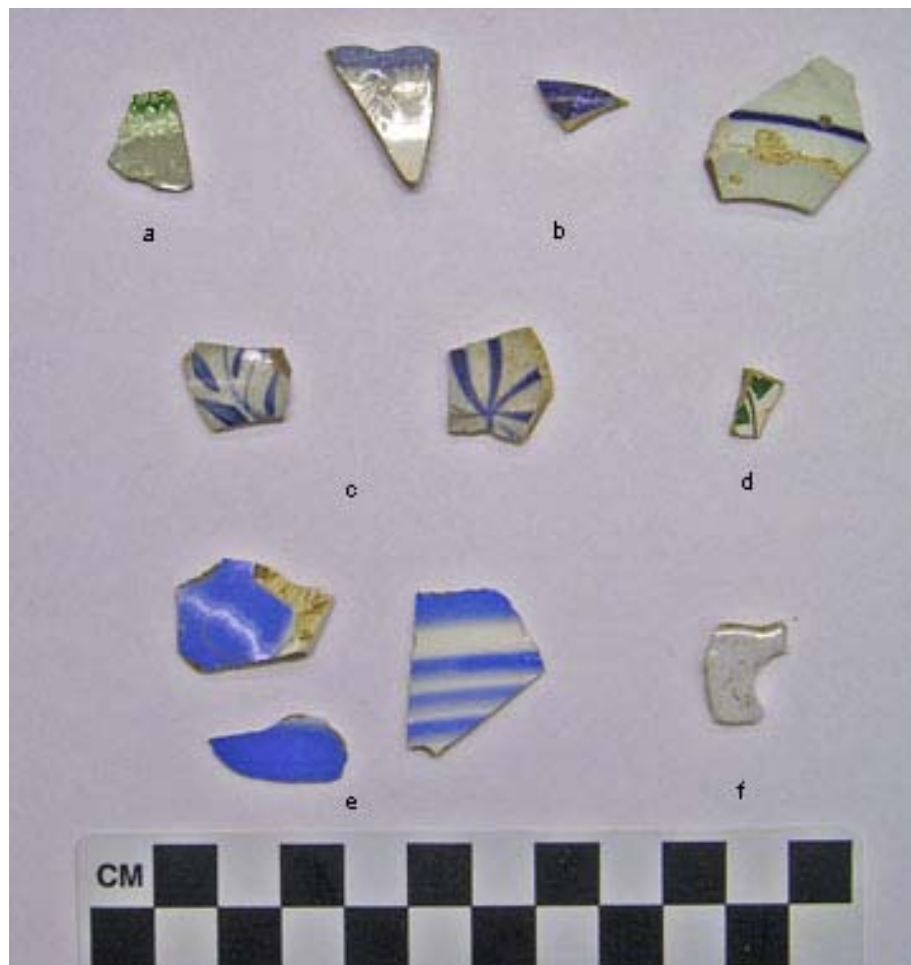
Figure 22. Decorated ceramics: a) molded edge, green glaze; b) flow blues; c) handpainted blue florals; d) handpainted polychrome floral; e) annular bands; and f) gilt transferprint.

and hand painted whitewares, and one transferprint on porcelain (Table 2) (Figure22). The porcelain fragment was recovered from the back yard. A mean ceramic date for the ceramics in the sideyard was 1845.8. Combined with the historic documentation, this date fits well with the original construction of the house between 1840 and 1850.
