The President Benjamin Harrison Home: Using Archaeology for the Interpretation and Reconstruction of the Carriage House

Prepared for:
Division of Historic Preservation and Archaeology
Indiana Department of Natural Resources

Report of Investigation #48

Archaeological Resources Management Service
Ball State University, Muncie, IN 47306-0435
Phone: 765-285-5328 Fax: 765-285-2163
E-Mail Address: Arms@bsuvc.bsu.edu

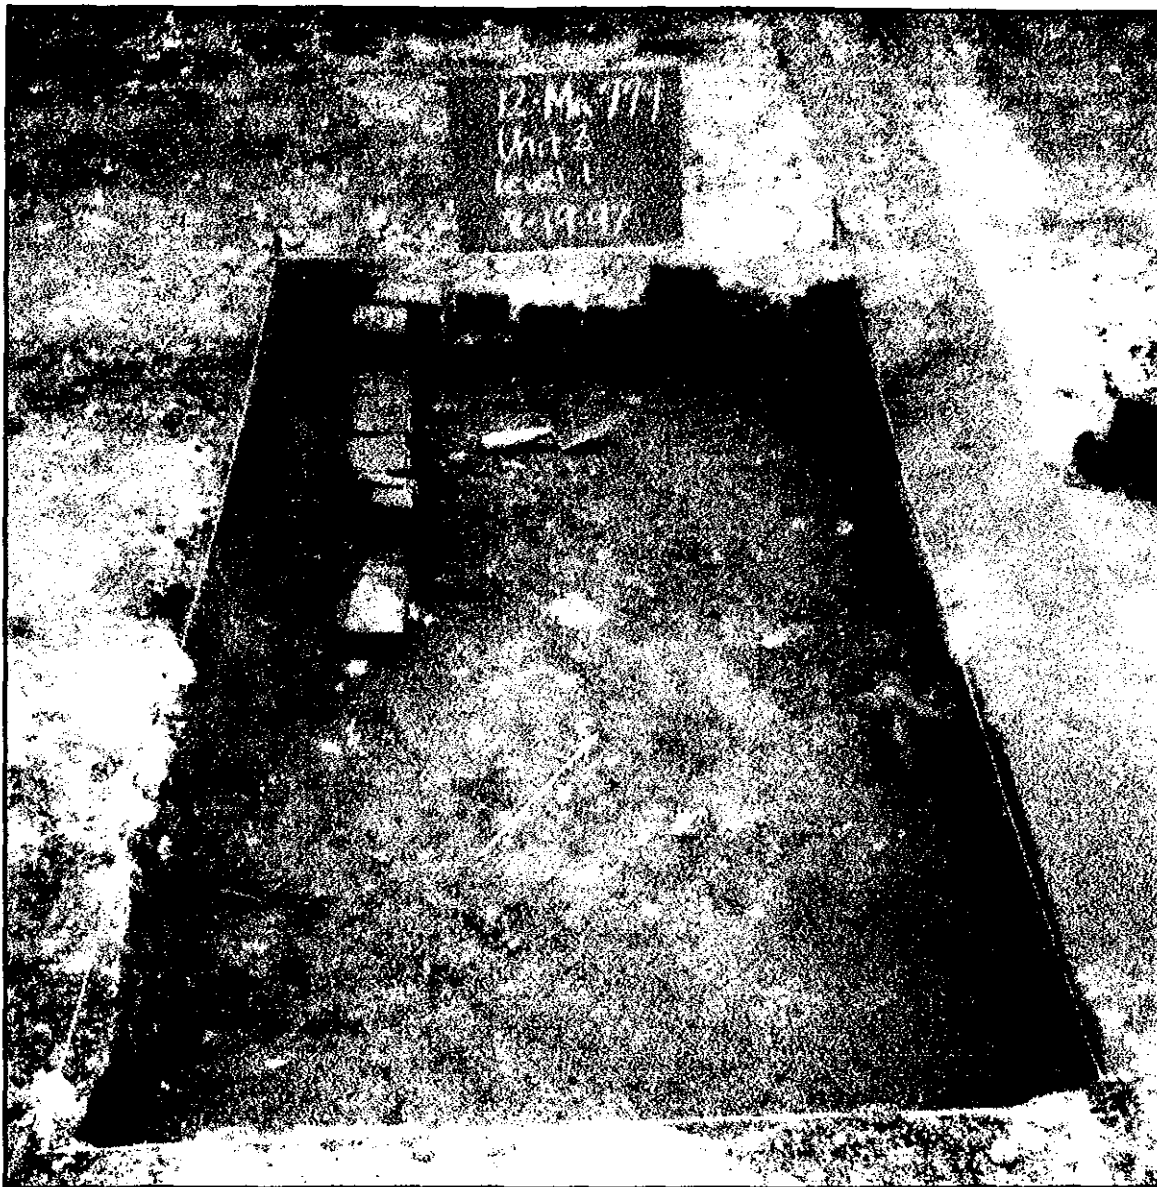
Figure 3.8. Feature 3 in Unit 3. Facing west. Notice the absence of the eastern feature boundary.

Unit 3: A rectangular-like feature (Feature 3) in the southern bay was revealed during gravel removal (Figure 3.8). The excavation unit was oriented east to west over it. The eastern edge of the feature was not discovered until approximately 40 cm below datum. The interior dimensions of Feature 3 is 107 cm E/W by 77 cm N/S by 85 cm deep. Its precise function was unknown. The walls of the feature were mortared to but not tied into the foundation. Therefore, its construction clearly post-dates that of the foundation, perhaps different phases of the same construction episode.

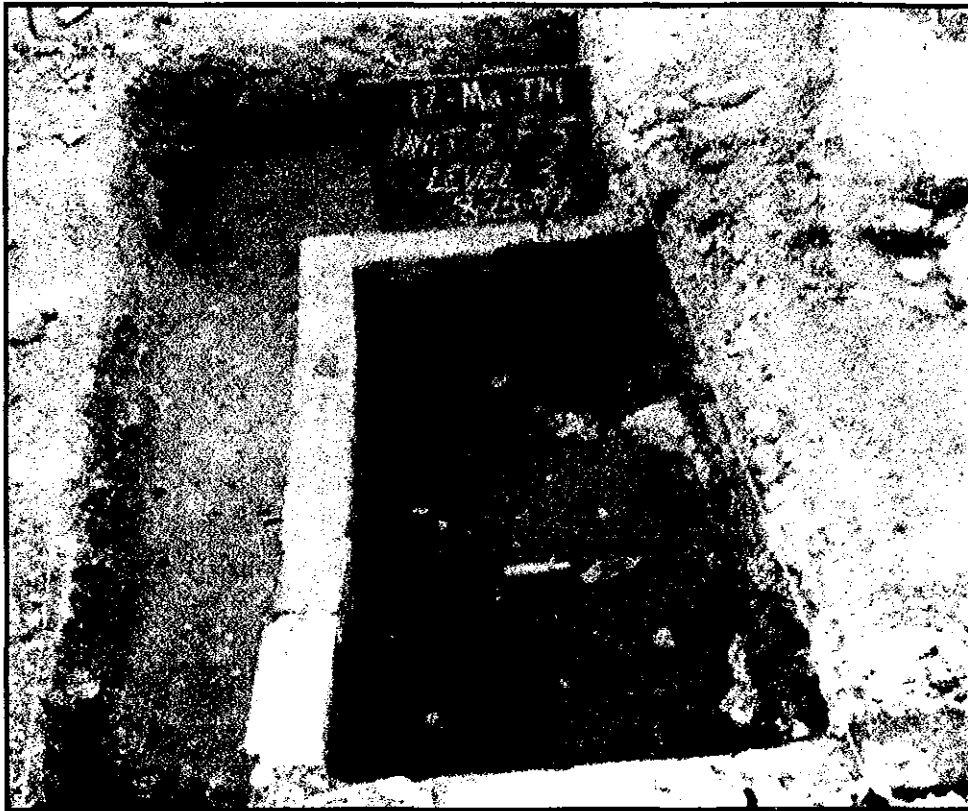
Figure 3.13. Feature 5, Unit 5 during excavation. Facing west.

Unit 5: This unit was placed over a rectangular feature (Feature 5) in the northeast corner of the carriage house and was almost identical to Feature 3 (Figure 3.13). Feature 5 was approximately the same size and depth as Feature 3 (75 cm N/S by 132 cm E/W by 90 cm deep). At the base of the unit were several large steam pipes which may have served the carriage house at one time.

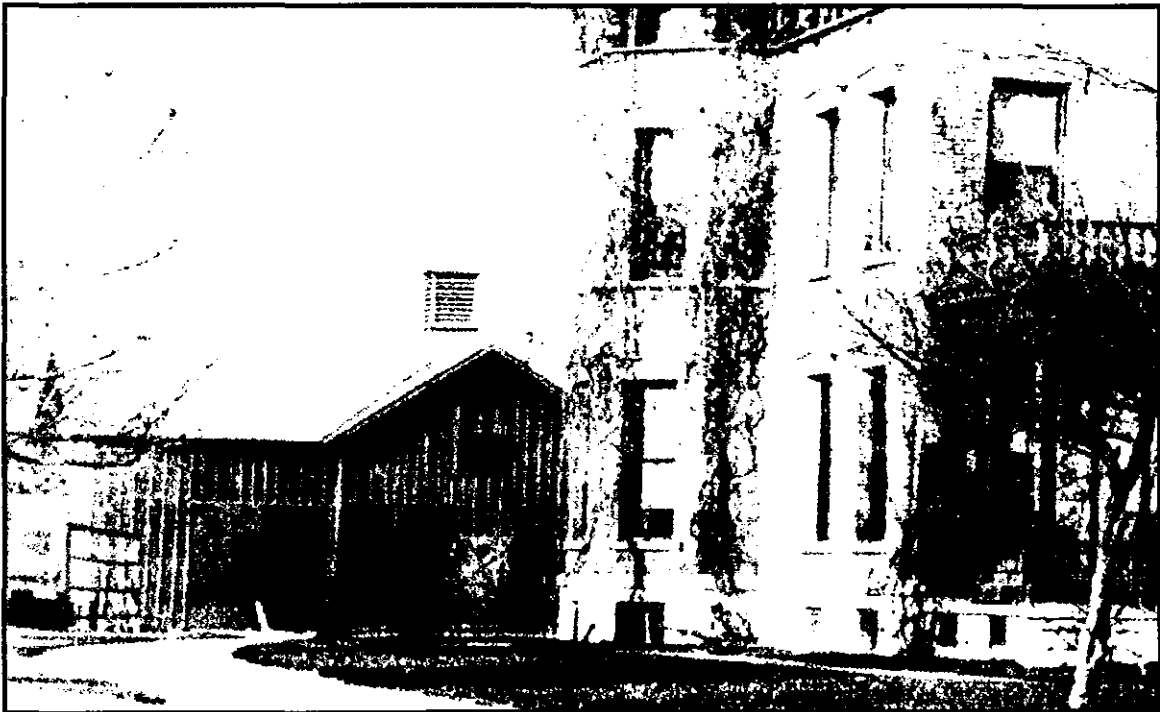
Figure 4.2. Photograph of the carriage house at the Harrison Home circa 1888. Facing west. Notice the alignment of the doors with the driveway. Courtesy of the President Benjamin Harrison Home Foundation.

The two exterior bays were slightly larger (5.6 m N/S by 6.8 m E/W) than the central bay (4.2 m N/S by 7.0 m E/W). The central portion of the structure also extended further to the east (by 20 cm) than the remainder of the building. The only photographs of the carriage house (circa 1888) showed a gabled roof on this section of the building (Figure 4.2).
